Crucible Base Oxidation

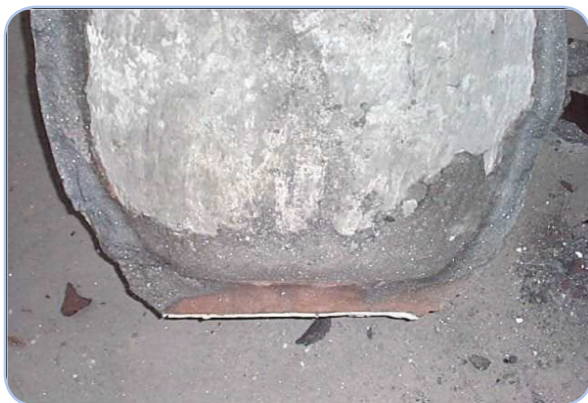
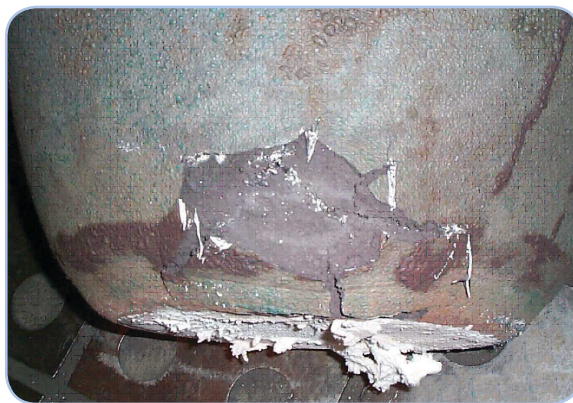
Ceramic fibre blanket should not under any circumstances be used as a parting medium between the base of the crucible and the crucible stand. The use of ceramic fibre blanket promotes thermal shock cracking and increased oxidation of the crucible material.

Ceramic fibre is an insulating material that will restrict heat flow where it is allowed to make contact with the crucible body. This in turn will prevent the external glaze from reaching its normal softening temperature, particularly during the vital pre-heating stage, and thus any micro-porosity or discontinuities that are present will not be sealed against the ingress of oxygen. Ceramic fibre materials contain predominantly alumina and silica. These components will react with the low melting point phases in the glaze coating and thus cause modification to the glass composition. The resulting elevation of the softening range of the glaze will result in greatly impaired performance at normal operating temperatures thus leading to premature oxidation of the carbon and silicon carbide within the body.

Crucible Base oxidation caused by using ceramic fibre as a parting medium between the crucible and base.
