# Case Study ResCoat Coating

Product name: ZYLS 815 x 610 with ResCoat Coating

Application: Copper alloy melting

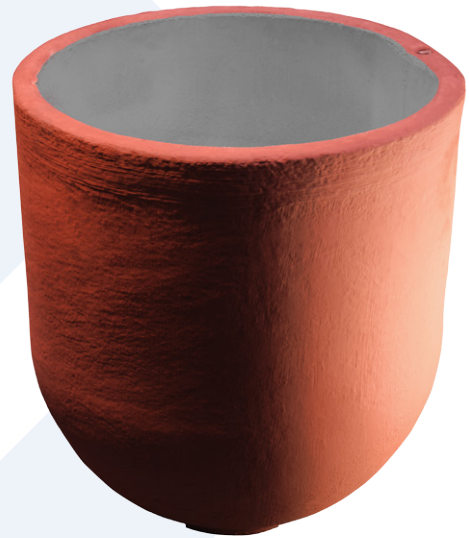
Picture: BNS 600 PT with ResCoat Coating

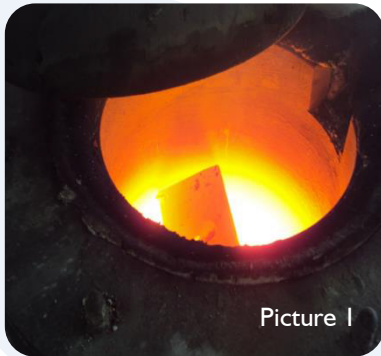
The customer was using an ISO pressed, clay bonded, cylindrical crucible for melting a Copper alloy in an induction furnace at 180 Hz. The low frequency operation created significant metal movement during melting which was wearing off the crucible faster and led to failure of the crucible by erosion.

Picture 1 SnPbZn copper alloy melting.

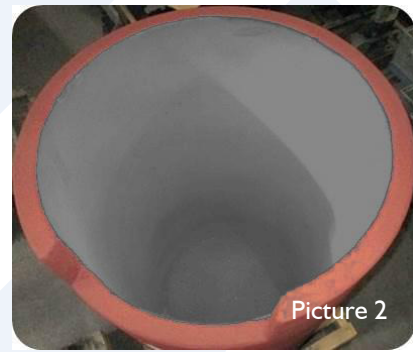
With ResCoat, the customer achieved 20% higher metal output over the crucible life. This was due to better erosion resistance provided by ResCoat which led to higher crucible life.

Picture 2 Syncarb with ResCoat Coating.

Product name	Production output	Improvement
Existing Crucible	34029 kg	+20%
Syncarb with ResCoat Coating	40823 kg
